**HISTORIC PRESERVATION REVIEW BOARD  
STAFF REPORT AND RECOMMENDATION**

Landmark/District:	<b>Cleveland Park Historic District</b>	<input type="checkbox"/> Agenda
Address:	<b>3615 Newark Street, NW</b>	<input checked="" type="checkbox"/> Consent
		<input checked="" type="checkbox"/> Concept
Meeting Date:	<b>October 27, 2011</b>	<input checked="" type="checkbox"/> Alteration
Case Number:	<b>11-519</b>	<input type="checkbox"/> New Construction
Staff Reviewer:	<b>Amanda Molson</b>	<input type="checkbox"/> Demolition
		<input type="checkbox"/> Subdivision

Owners George & Nora Stavropoulos, with drawings prepared by Mr. Stavropoulos, request concept approval for front porch reconstruction and a rear addition to 3615 Newark Street, NW in the Cleveland Park Historic District.

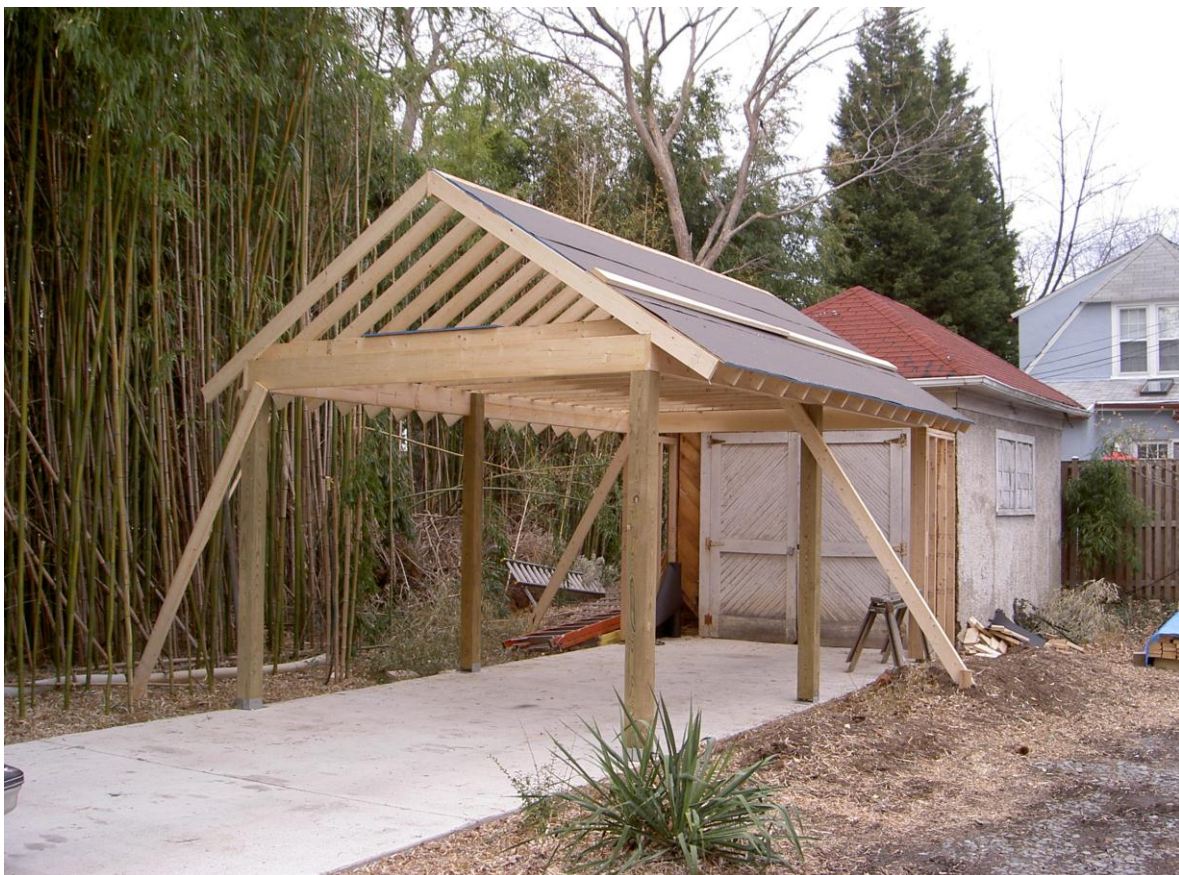
Though not included in this current set of plans, the owner has expressed interest in removing the carport currently blocking street views of the property's early garage. The carport was constructed in 2004 by a previous owner who did not obtain the required permit. After being cited by the HPO, that owner appeared before the Board in March of 2004 to request approval for an after-the-fact permit. Approval was granted with some modifications to the as-built structure, but it remains an unfortunate addition to the property. The HPO would welcome and encourage removal of the carport as part of the current project or in the future, approval for which could be handled at without further Board review.

Photo by the HPO (2004), showing unpermitted carport mid-construction
